Manhole Inspection Summary

Manhole # S51E__011MH

Insp Date: **5/8/08 10:50 AM**

Location Address: **2939 e baltimore st**

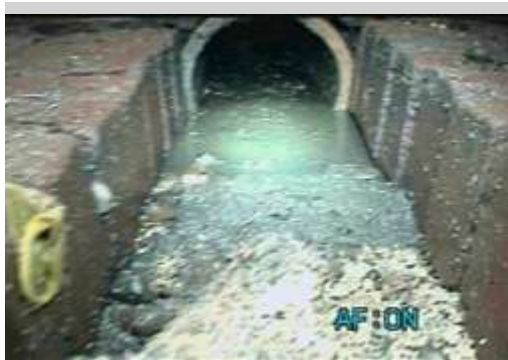
Defect

Condition: ☐ Sound ☐ Cracked ☐ Root Intrusion ☐ Deteriorated ☐ Leaks ☒ **Debris**

channel debris

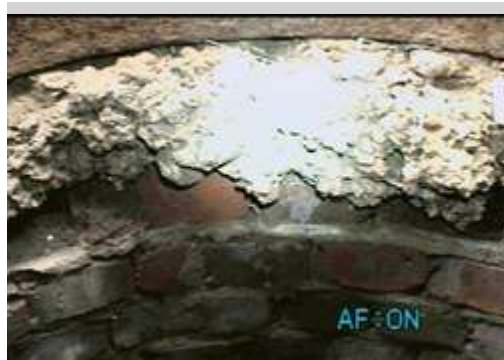
Defect 1

Condition: ☐ Sound ☐ Cracked ☐ Root Intrusion ☒ **Loose Brick** ☐ Deteriorated

chimney loose bricks

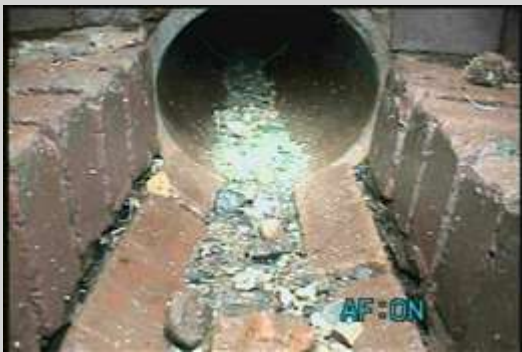
12 O'Clock Outflow

Infiltration: Evidence Pipe Seal Cond: Unknown

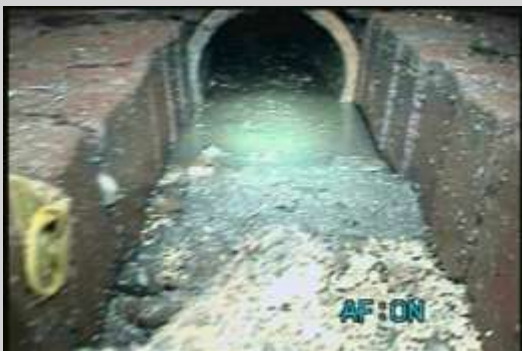
6 O'Clock Inflow

Deposits: ☐ None ☐ Mud ☐ Sludge ☒ Debris ☐ Grease

Silt Depth: 2 (in.) Deposits Extent: Medium
